Waste Delineation and Characterization, Makah Landfill, Neah Bay, Washington

# WASTE DELINEATION AND CHARACTERIZATION

## MAKAH LANDFILL NEAH BAY, WASHINGTON

DECEMBER, 1995

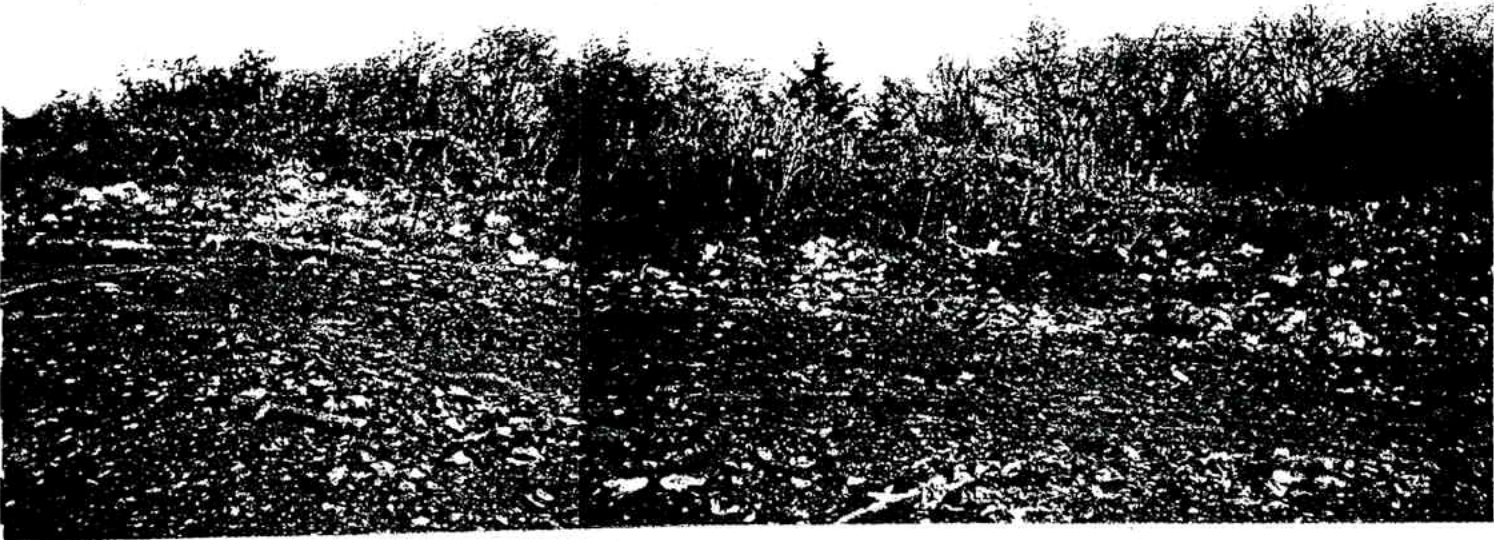
Test Pit # 4 was excavated on the North- northeastern extremity of the landfill to a depth of 5'. The waste material was well-compacted ash and organic material with nets, glass and metallic and wood debris, and it extended to a depth of 4'. One composite waste material sample was collected from this site and one substrate sample was taken from a depth of 5'.

PHOTOGRAPH #4: LOOKING NORTHEAST, TOWARD TP #4

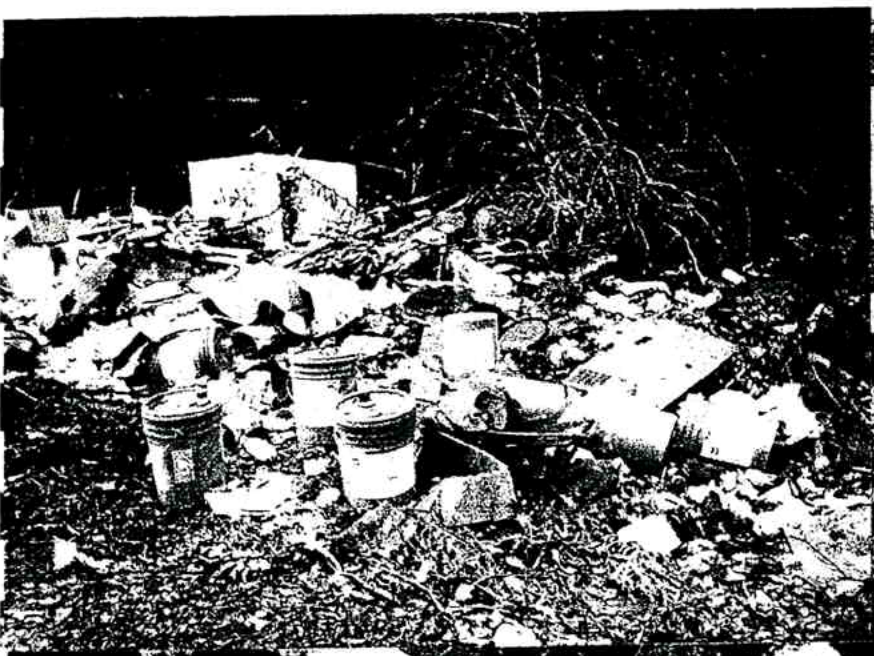
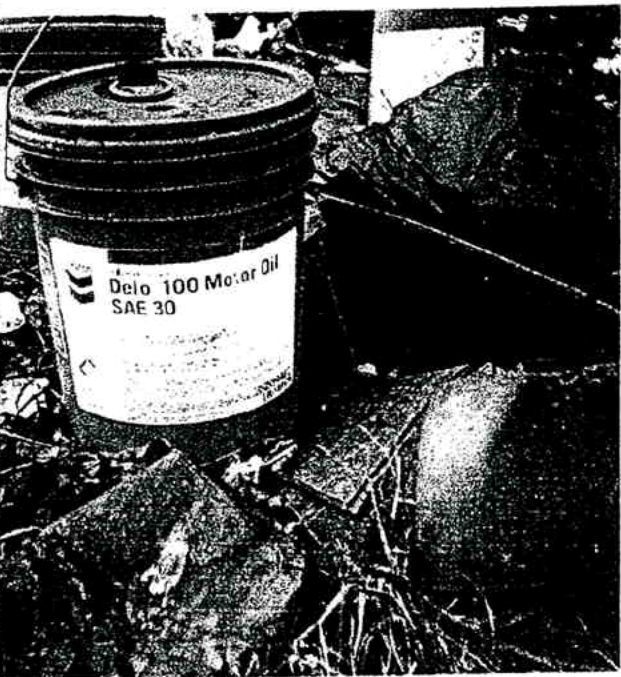
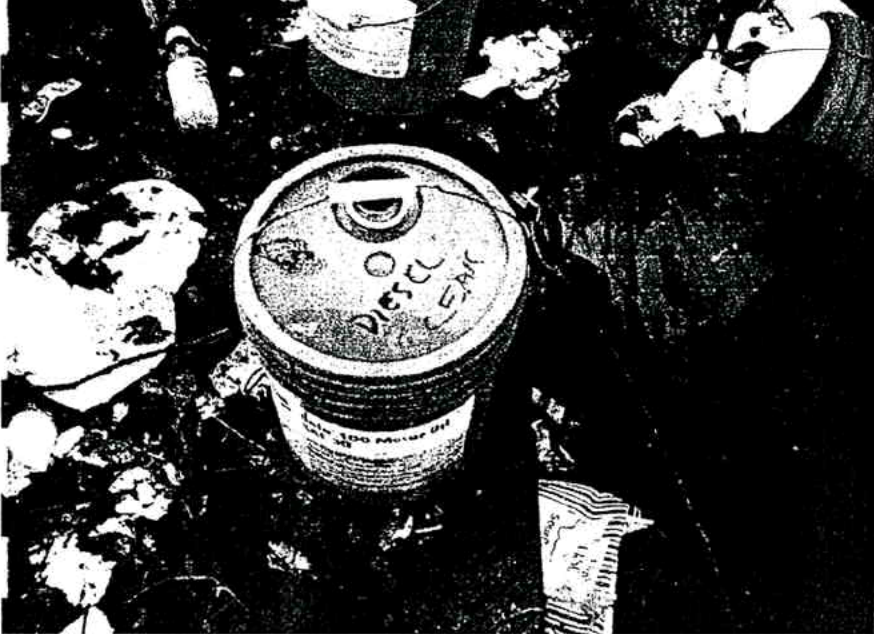
Potentially hazardous waste noted included 2 batteries, about fifteen (full to partially full with no sign of spillage) 10 gallon plastic storage containers labeled as motor oil, but with unknown contents (shown in photographs 5, 6, and 7), one hypodermic needle, approximately 7 to 10 % of the material is tires, and 15 to 20 % of the material is composed of appliances which may contain residual ammonia or other potentially hazardous material. There was some roofing and other construction material present that consisted of less than 1% of the total landfill material. The remainder of the waste was unidentifiable organic material including carcasses and parts of carcasses, a large percentage (20 to 30%) metal composed of car bodies, appliance parts and other unidentifiable metal framework. Of the small cans noted on site, approximately 75% were aluminum. There is an estimated 20 to 30% glass, both colored and clear, broken and unbroken. There was a striking percentage (25 - 30%) of visibly reusable items such as toys, clothing, blankets and a sleeping bag, furniture, wood, weights and tools.

PHOTOGRAPHS 5,  
6 & 7,  
UNIDENTIFIED  
WASTE DRUMS

4. Send the roofing sample for asbestos analysis.
5. Attempt to find the person or party who left the unidentified material contained in the small blue drums (photos 5, 6 & 7), or sample the material to identify it.

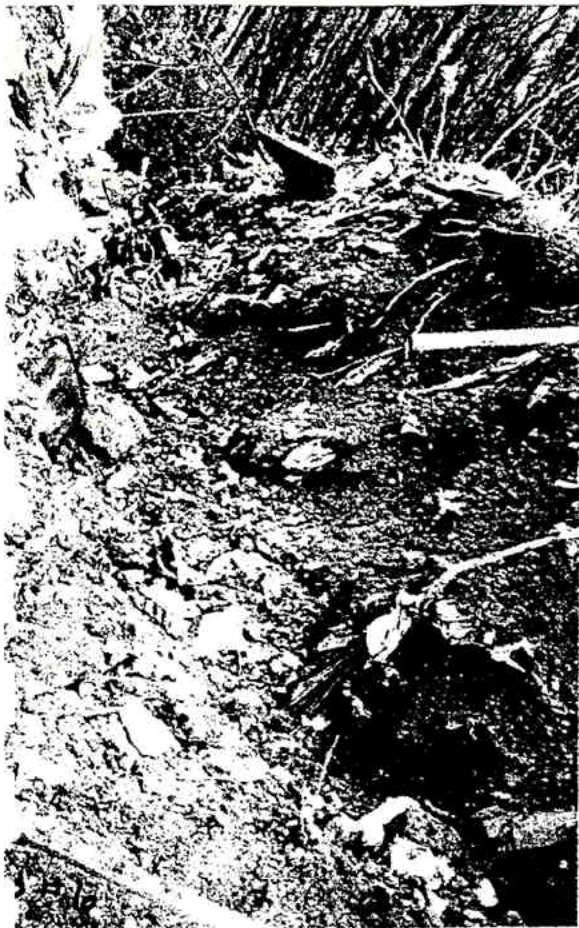
Test Pit # 6 is the northern most pit and it was excavated to a depth of 2'. Garbage material was surficial in this area, and consisted of organic material, wood, glass, tires, furniture and glass. This area has not been burned. One composite sample of the waste was collected here and one sample of the substrate material was taken from a depth of 2'.

PHOTOGRAPH 8: T.P. 6, LOOKING NORTH
